EASEMENT WITHIN THE SILVER HOUSES HISTORIC DISTRICT

ational Register of Historic Places Nomination Form

Silver Houses Historic District
Continuation sheet Harford County, Maryland Item number 4

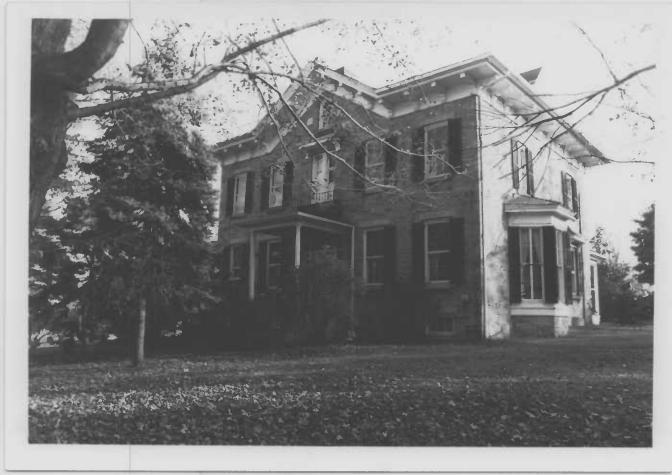
Silver Houses Historic District (Silas B. Silver House - HA-407)
Darlington vicinity
Harford County, Maryland
Photo: Janet Davis
November 1982
Neg. location: Maryland Historical Trust
North elevation
35 of 48

5. Dr. Silas B. Silver House (HA-407), "Silverton" - 3643 Harmony Church Road. Seven buildings. 1859 2-1/2 story Italianate-influenced stone house with five-bay principal elevation facing north. Central gable with arched window flanked

by inscribed stones reading "1859" and "Dr. S & Mrs. S". Central entrance has flat-roofed entry porch, a mid-20th century replacement of original larger porch with open upper level reached via french doors on second floor. Bracketed hood over french doors. Three-sided bay window on first floor west elevation. Bracketed cornice, slate roof with interior chimneys and single dormers facing east and west with paired arched windows and oculi. Mid-1960's enclosed porch on east elevation; mid-1960's screened porch on south elevation. No substantial loss of integrity, although enclosed porch on east is current main entrance and thus most common view of house. Double walnut doors at main entrance. Central hall plan with two rooms on each side. Marble mantel in west parlor is only remaining original in house. All fireplaces closed off except in second parlor or family room. Mahogany stair rail; scroll-sawn closer ornament. Stone combination smokehouse/root cellar with hipped shingle roof and cupola and frame on stone foundation woodshed, also with hipped shingle roof and cupola, both located south of house. Frame henhouse southwest of house, now used for storage. Ca. 1965 concrete block garage east of house.* Frame carriage house east of garage; vertical siding, scalloped bargeboards. Frame bank barn on stone foundation east of carriage house; vertical siding. Frame corn crib south of carriage house; vertical siding.

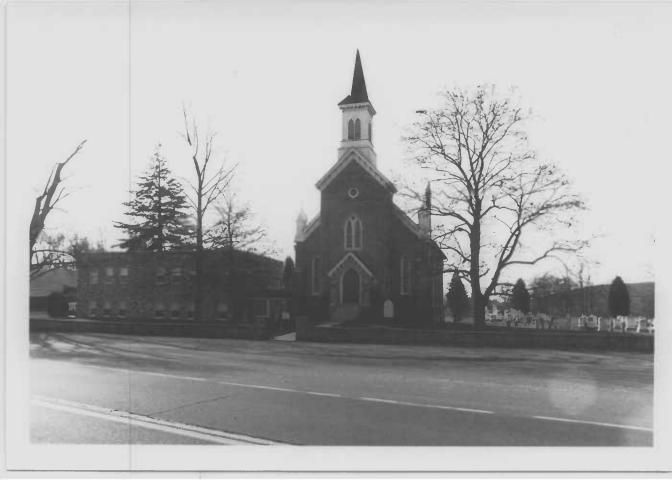
Silver Houses Historic District HA-408
(Deer Creek Harmony Presbyterian Church HA-165)
Darlington vicinity
Harford County, Maryland
Photo: Janet Davis
November 1982
Neg. location: Maryland Historical Trust
General view from northeast
43 of 48

6. Deer Creek Harmony Presbyterian Church (HA-165) - southwest corner of Harmony Church Road and Darlington Road. Three buildings. 1871 Gothic Revival stone church with bell tower and spire over projecting foyer facing northeast. Slate gable roof; brick chimney projecting from north slope of roof. Plaque located on southeast corner inscribed "Completed in 1871, Dedicated debt-free

in 1872". Four lancet stained glass windows on each side of rectangular sanctuary; recessed niche behind pulpit on raised platform at southwest wall. Interior walls plastered and stencil bordered; last repainted in 1968. Corner stairway to basement added 1954. Covered walkway on south connects church with two-story stone veneer education building built 1965.* Cemetery located north and west of church; stone hipped roof tool shed built 1958*west of church at edge of 4-foot stone wall bordering church property. Iron gates in wall at front of church. Slate marker in wall north of church indicates location of 1837 church.

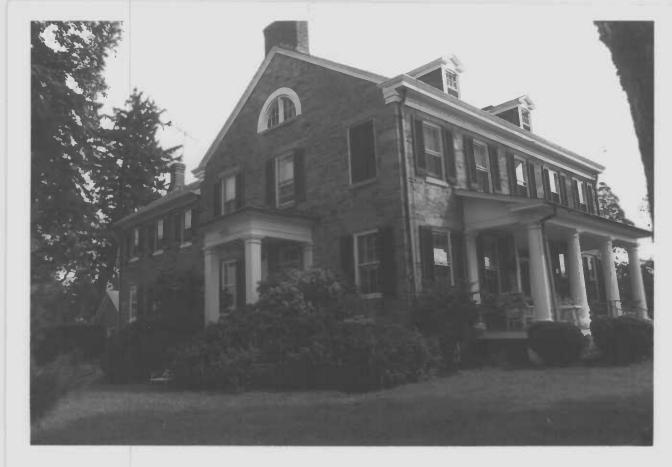
Silver Houses Historic District (Benjamin Silver House - HA-398)

Darlington vicinity
Harford County, Maryland
Photo: Janet Davis
August 1983
Neg. location: Maryland Historical Trust
West and south elevations
12 of 48

Benjamin Silver House (HA-398-406) - 3646 Harmony Church Rd. Twelve resources. HA-398: 1856 2-1/2 story Classical Revival-influenced stone house with five-bay principal facade facing south; one-story porch with four Tuscan columns. Plain cornice; slate roof with two dormers in south elevation; interior end chimneys. Entry porch on west elevation with two square columns. Stone rear wing with frame mid-20th century addition on east. Datestone in east gable of main section inscribed "BS 1856". Central hall plan with two rooms on each side. Recessed panel walnut doors and paneling at window openings. Marble mantels in parlor and dining room. Mahogany stair rail with scroll-sawn closer decoration. Ca. 1850 log smokehouse located west of house near fence; gable roof; single door in south elevation; square windows in east and west elevations. Ca. 1860 frame tenant house stands south of barn near Harmony Church Road; one story, five-bay principal facade on south. Slate gable roof extended on east over open porch. Aluminum siding. HA-399: Frame bank barn on stone foundation located 40 yards southeast of main house. Principal entrance on north. Slate roof shows evidence of patching in center, indicating possible original cupola location. Hand-hewn interior structure; vertical wood and red aluminum siding. Concrete block extension on east. Stone wall on south around barnyard. Two modern silos on north side. HA-400: Stone dairy located immediately north of rear wing of main house, one story with frame addition on east elevation. HA-401: Frame slave quarters located immediately northeast of dairy. Two stories; hipped slate roof; vertical red aluminum siding. Altered in mid-20th century for furnace room on ground floor and children's playroom on second floor. HA-402: Stone smokehouse located immediately east of slave quarters.
